Manhole Inspection Summary

Manhole # S29CC1017MH

Insp Date: **12/13/06 9:49 AM**

Location Address: **3701 KESWICK RD**

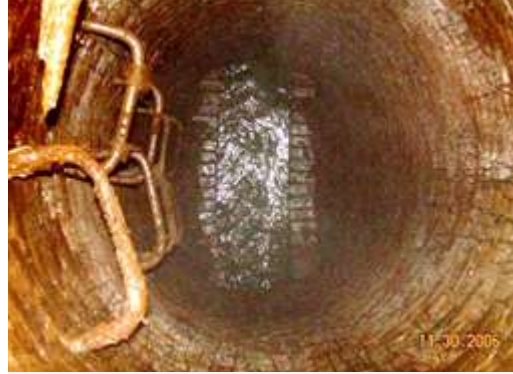
Top View

Corroded and missing steps. Bench debris.

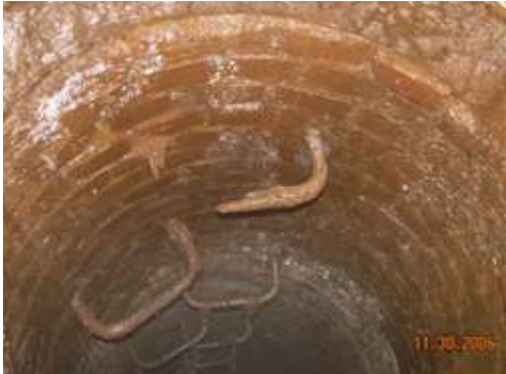
Defect

Adjustment deterioration and infiltration. Corbel and Barrel infiltration. Corroded and missing steps.

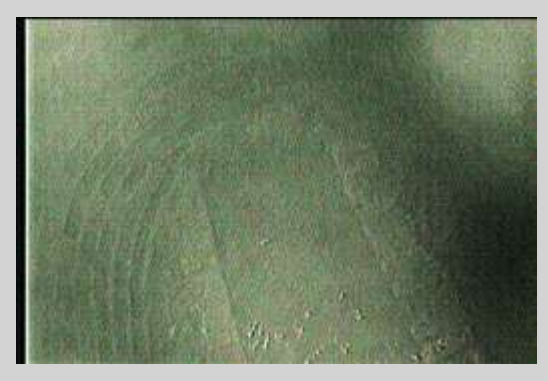
10 in. Circular Gravity Sewer Pipe Out @ 12 O'Clock

Deposits: ☒ None ☐ **Mud** ☐ Sludge ☐ **Debris** ☐ Grease

Infiltration: **None** Pipe Seal Cond: **Unknown**

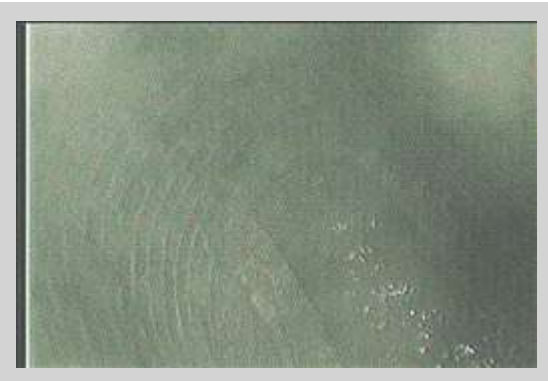
10 in. Circular Gravity Sewer Pipe In @ 5 O'Clock

Deposits: ☐ None ☒ **Mud** ☐ Sludge ☒ **Debris** ☐ Grease

Silt Depth: **0** (in.) Deposits Extent: **Medium**
